# Walkability Audit

05/11/2019

**Scoil Raifteri**  
**Castlebar, Co. Mayo**

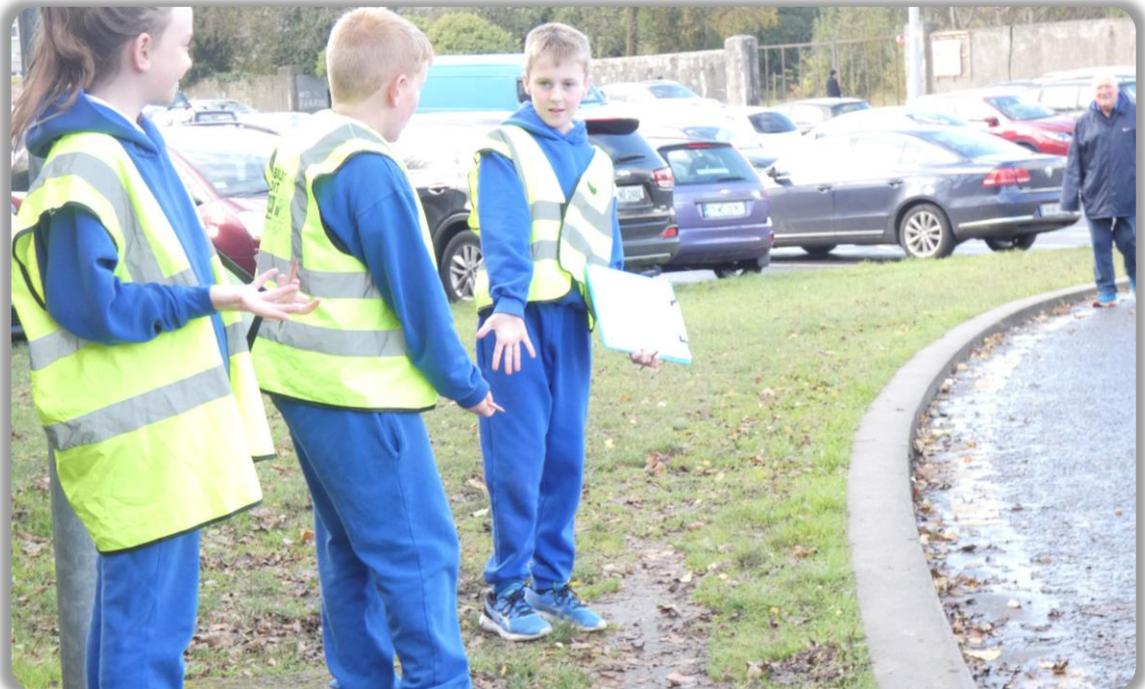
## Description of the route audited:

The group walked from the school (red pin) to the Castle Street Car Park (5) using the newly laid out pedestrian crossing (1) in front of the school. On the way back the group went a bit further on the main road leading to school to look at the roundabout (6) near Lidl and Davitt College.

The school identified some places where cars are put first instead of pedestrians (2,3,4)

The distance of 650 m to the car park takes about 7 min to walk and the children counted 551 steps.

4. Remove or redesign the car parking near the Castle St roundabout so that vehicles do not freely cross the footpath. Currently this presents a safety hazard to students using this footpath on a daily basis. (See 3 on map above and in photos below)

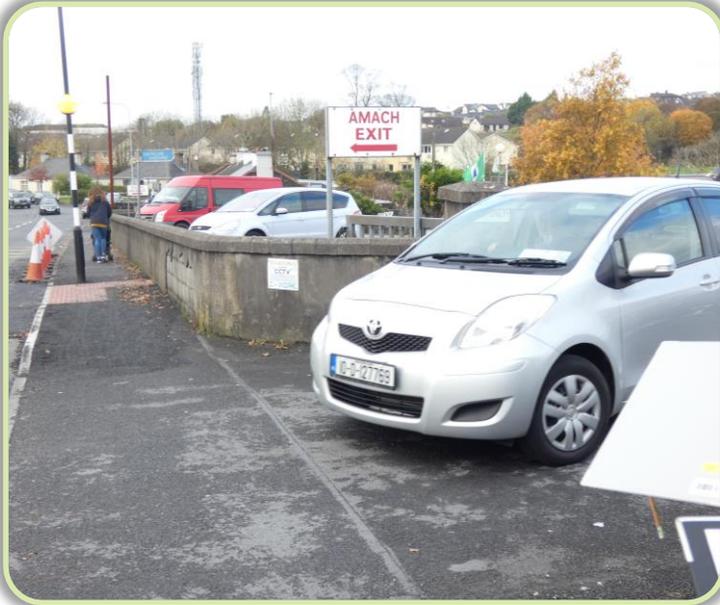
Way in and out of school car park is shared space between cars and pedestrians, poor visibility for the drivers

Clearly mark the entrance and exit. Stop sign on the way out. Different paving to prioritise pedestrians

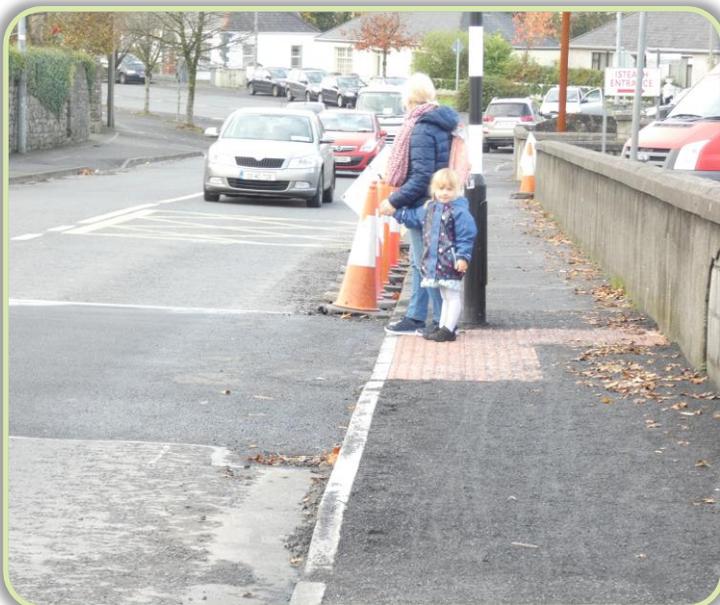
The new pedestrian crossing (2 on the map) is not finished, no markings on the road

Clear markings to make the crossing more visible

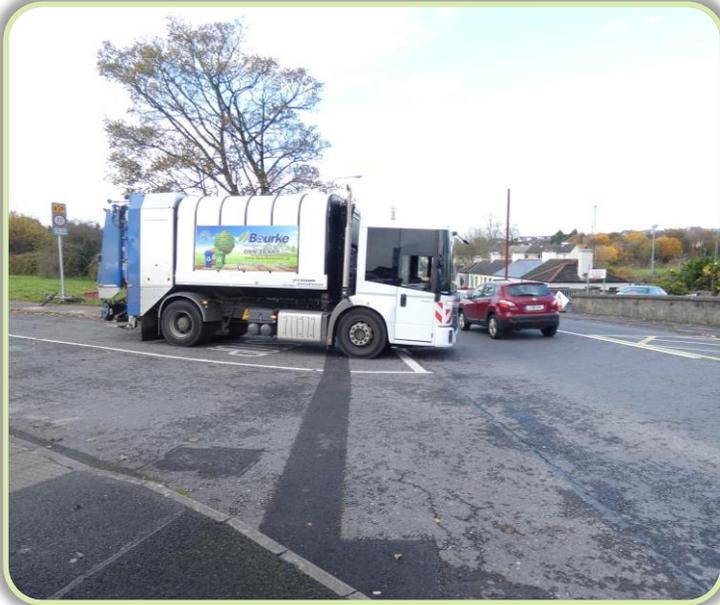
A lot of students need to cross this road (2) beside Davitt College to continue to the Castle Street car park, a wide road, that is marked for cars instead

Indicate a space for pedestrians with some markings or make a new crossing

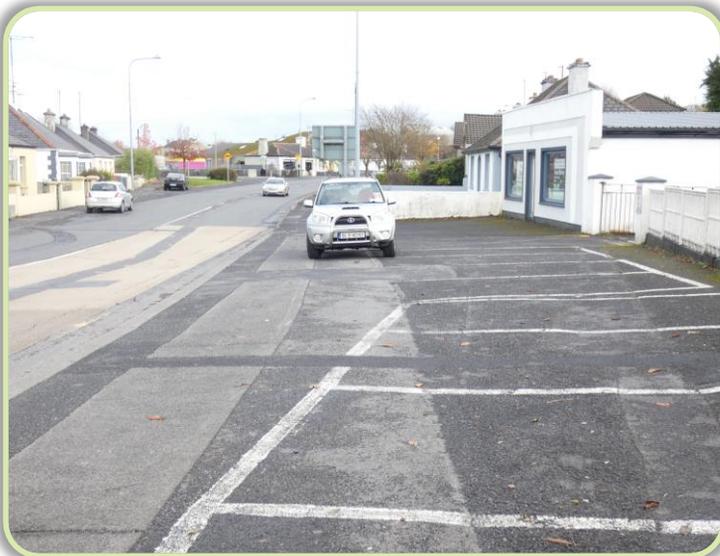
Parking on the footpath beside the Castle Street (3) round about, used frequently the parents, cars need to go over the footpath to get to the parking space making it dangerous for walkers

No car park or redesign so cars can go in and out without driving on to the walkers space

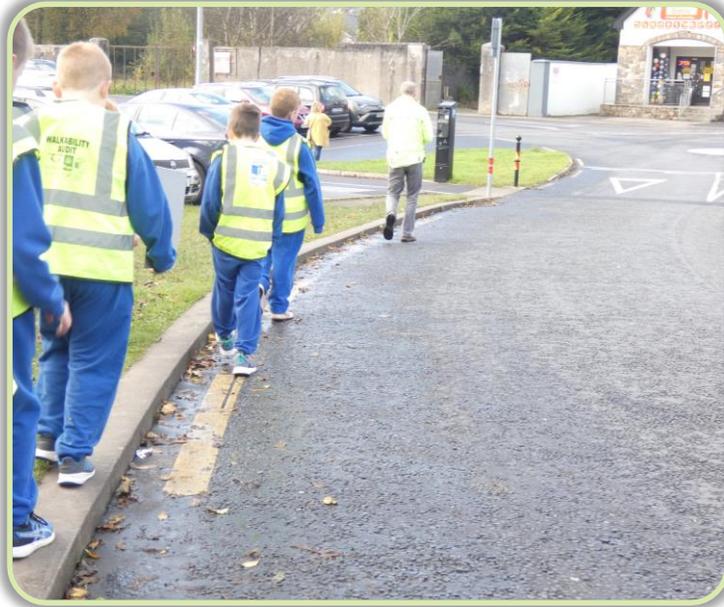
Footpath suddenly ends before it reaches Castle Street car park. Pedestrians need to go on the road to get to the car park.

Follow the trail of the pedestrians on the grass where they try to shortcut it to car park and finish it with the footpath.

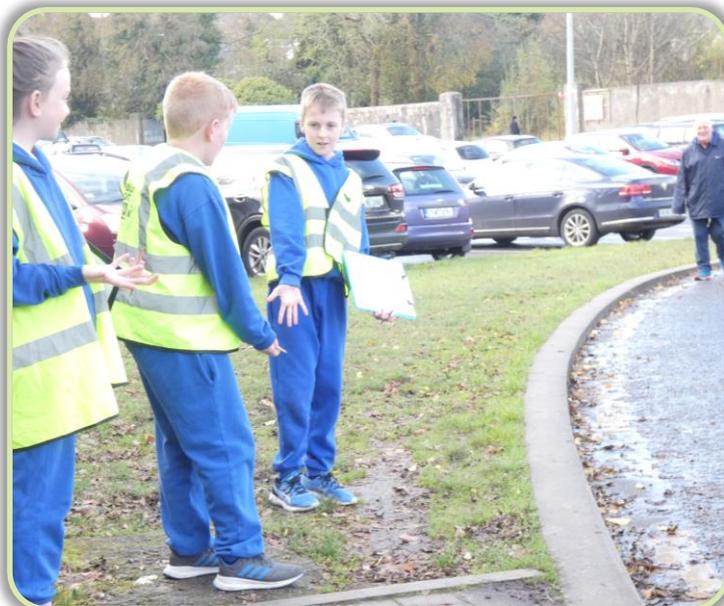
Same as above  
(5 on the map)

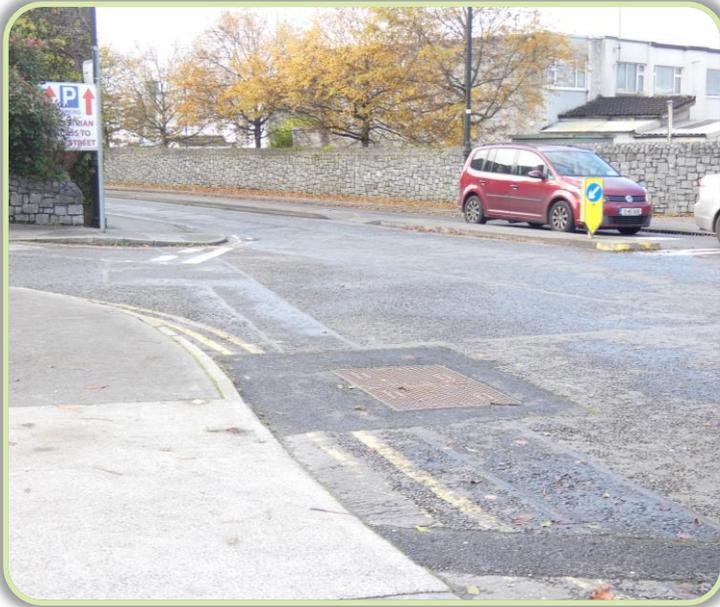
Poor visibility of the crossing  
at Castle Street (4 on  
map)

Make the crossing more  
visible to the drivers with  
appropriate markings or

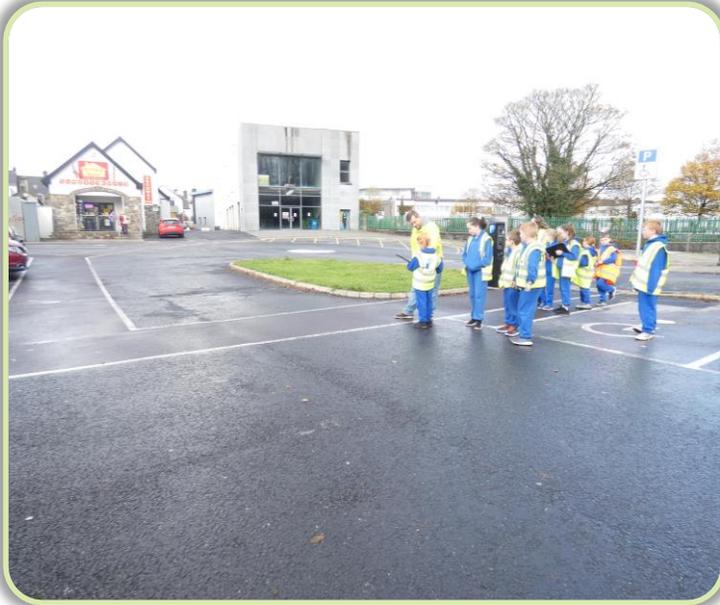
Castle Street car has some lines indicating where the pedestrians could walk but the cars are driving all over the lines

Bollards?

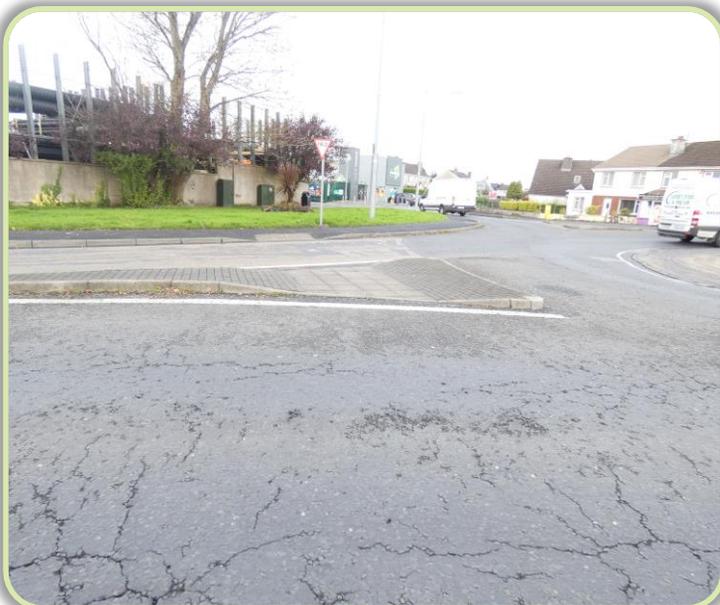
Pedestrians crossings around the LIDL roundabout are not clearly marked (6 on map)

Clear markings would make the pedestrians safer as it would alert the drivers
